Manhole Inspection Summary

Manhole # S33KK_017MH

Insp Date: **11/30/06 10:30 AM**

Location Address: **1901 HOWARD ST**

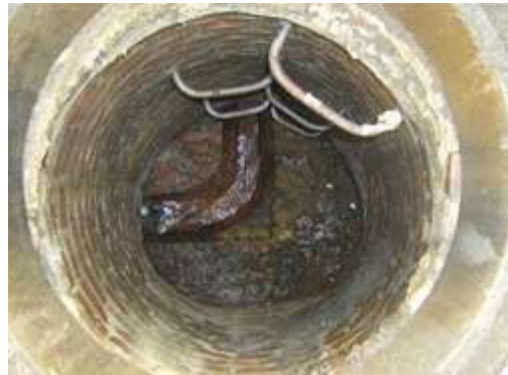
Top View

Evidence of surcharge - Bench debris.
Channel debris.

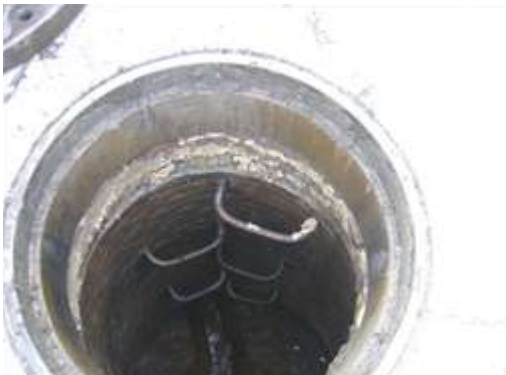
Defect

Frame Offset: **2** (in.) Condition: ☐ Sound ☐ Cracked ☒ **Leaks**

Condition: ☐ Sound ☐ Cracked ☐ Root Intrusion ☐ Loose Brick ☒ **Deteriorated**

Infiltration: ☐ None ☒ **Joint** ☐ Cracks ☐ Mortar ☐ Roots ☒ **Wall**

Frame leaks. Frame offset. Adjustment
deterioration and infiltration. Corbel and
Barrel infiltration.

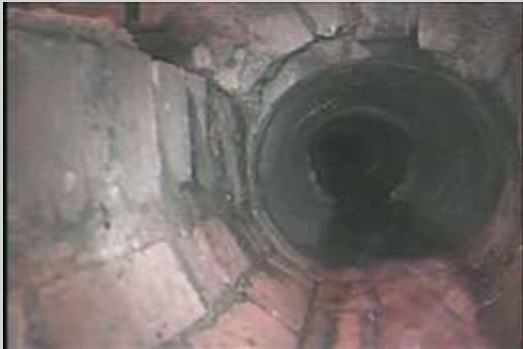
10 in. Circular Gravity Sewer Pipe Out @ 12 O'Clock

Infiltration: **Evidence** Pipe Seal Cond: **Unknown**

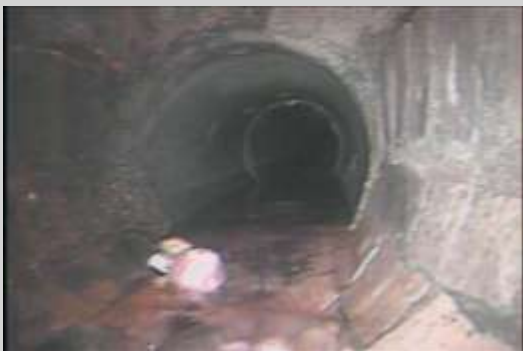
10 in. Circular Gravity Sewer Pipe In @ 9 O'Clock

Infiltration: **Evidence** Pipe Seal Cond: **Unknown**
